Title: Summary of Plutonium Oxide and Metal Storage Package Failures

Submitted to: Journal of Nuclear Materials Management

SUMMARY OF PLUTONIUM OXIDE AND METAL STORAGE PACKAGE FAILURES

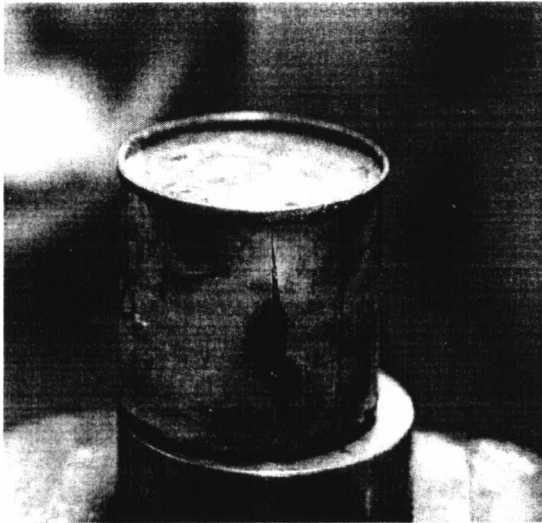
To illustrate the metal oxidation failure mode, we cite an incident at LLNL which was discussed in detail by Dodson and summarized as Case SEAL-5 in Table 1.²⁰ In this instance, air entered an inner aluminum can through incomplete sealing of the container, followed by conversion of the plutonium metal to oxide and mechanical failure of the container. Failure occurred within three years of packaging. The can was found to be split along its entire length as a result of expansion of the oxidized metal. Figure 1 shows a photograph of a container that failed similarly at RFS in 1982 (Case Seal-4, Table 1).

Figure 1. Photograph of a rim-sealed aluminum container that ruptured due to excessive mechanical pressure from oxidized plutonium metal, due to a faulty seal. This event occurred at Rocky Flats in 1982 and is described as case Seal-4 in Table 1.

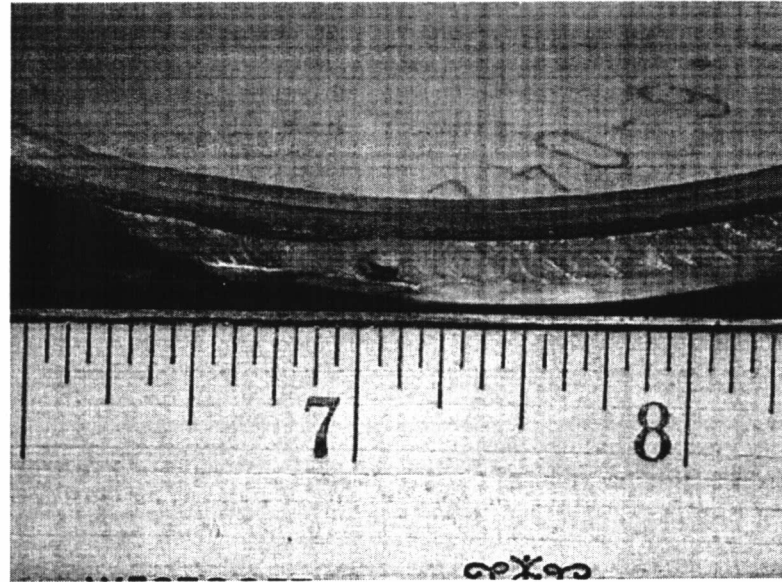
A September 1999 event at SRS (Case SEAL-9, Table 1) provides a special case of metal oxidation in non-airtight packages. To the author's knowledge, this is the only example of a significant failure of an actinide metal or oxide storage package since vulnerability assessments were published in 1994. In this instance, a defective closure weld was made on a stainless steel container enclosing a metal button.^{22,23} A photograph of the defective weld is shown in Figure 2. The weld inspection and testing process failed to detect this defect. The non-airtight container was placed into vault storage without secondary containment. Fifteen months later when the container was handled, extensive vault contamination and plutonium ingestion by seven workers occurred. Inspection of the container contents showed that extensive oxidation of the metal occurred during storage, generating easily-suspendable oxide in the container that moved through the weld defect when the container was handled.

Figure 2. Photograph of a defective closure weld on a stainless steel storage container that led to an incident in September 1999 at Savannah River, causing uptake of plutonium by seven personnel and extensive vault contamination. This event is described as case Seal-9 in Table 1.

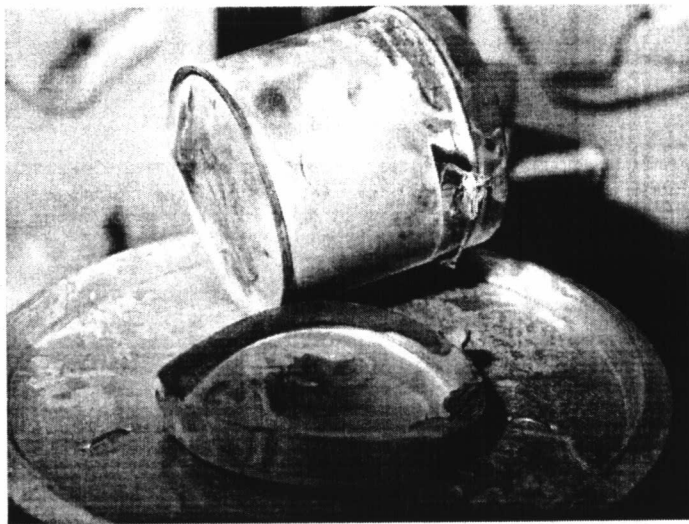
b. Gas Pressurization. As indicated in numerous technical reports and publications, failures of packages containing plutonium oxide have occurred because of excessive gas generation. Examples are given in references 2-4. Table 2 lists the seven documented cases of this failure mode. The root causes stem from radiolytic and thermal degradation of inadequately stabilized material or the presence of organics including plastic. Figure 3 shows a photograph of a Hanford container that failed in 1980 by gas pressurization (Case Pressure-5, Table 2).

Figure 3. Photograph of a slip-lid can that ruptured due to excessive gas pressure. This event occurred at Hanford in 1980 and is described as case Pressure-5 in Table 2.

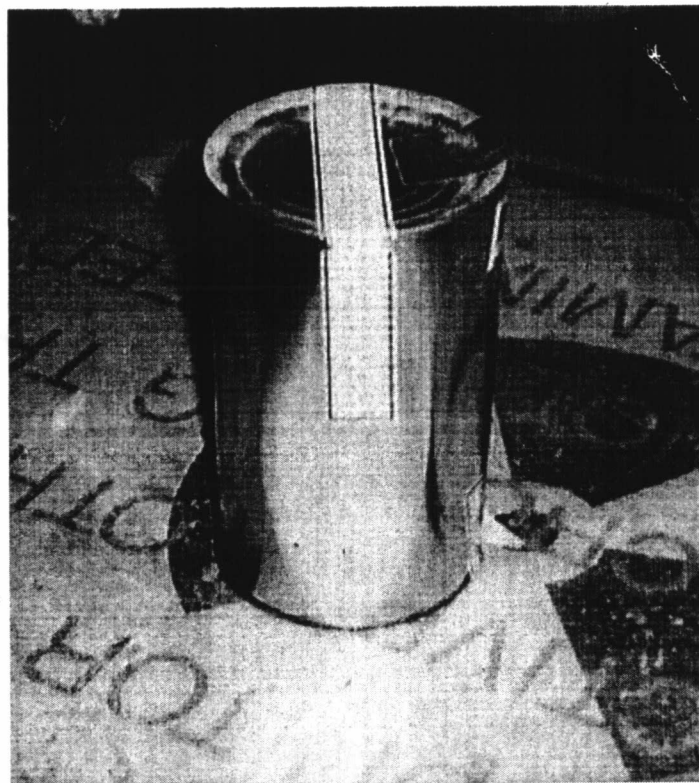
Figure 4. Photograph of a "paneled" rim-sealed Hanford container of plutonium metal that did not release contamination. Several examples of the paneling phenomenon are listed in Table 3.

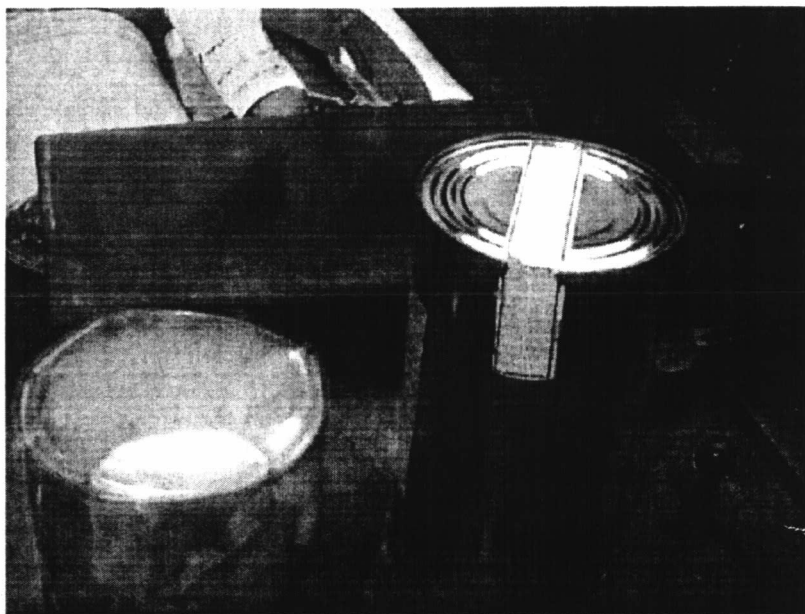
Figure 5. Photograph of a bulged Hanford rim-sealed container of plutonium oxide that did not release contamination. Other examples of the bulged can phenomenon are given in Table 3.
